## HIT Linac upgrade

### Introduction

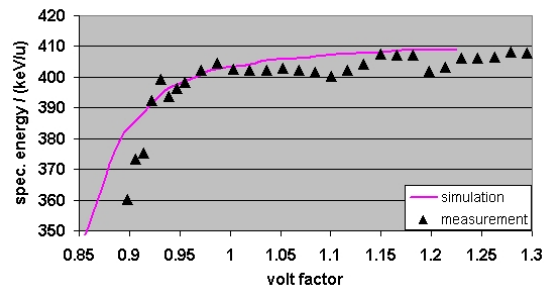
Figure 3: Measurement of the RFQ beam energy versus the volt factor (corresponds to rf-voltage).

The beam commissioning at Risø took place in autumn 2008. In summary the results were, that the power consumption of the RFQ is above 200 kW and thus too high for operation in Heidelberg. The steering of the RFQ depending of the rf-power is stronger than tolerable. The rebuncher voltage was not adjustable within the geometrical limits. Additionally the measured RFQ energy, depending on the rf-power, shows a 'wavy' structure (Figure 3). Furthermore, it was not possible to determine the transmission of the RFQ due to insufficiently defined beam parameters at the RFQ entrance.

The suspected reasons for this unexpected and intolerable behaviour are a misalignment of the electrodes, a too strong influence of the modified rebuncher section on the field distribution and not sufficiently defined beam parameters from the LEBT at Risø.

End of 2008 the RFQ was transported to IAP and there its mechanical and rf-properties will be revised. Depending on the results the whole structure might be reassembled and finally a new location and time has to be found for commissioning of the RFQ and adjusting the rebuncher.
